## FACILITY COMPLIANCE INSPECTION REPORT

### Division of Waste Management Solid Waste Section

**Date of Site Inspection:** 7/12/12

Henderson County Solid Waste Transfer Facility  
802 Stoney Mountain Road  
Hendersonville, NC 28791

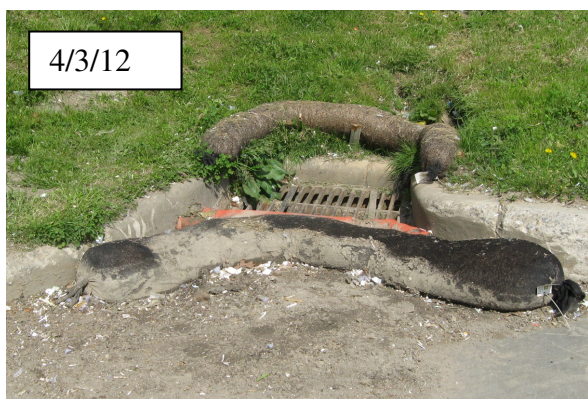
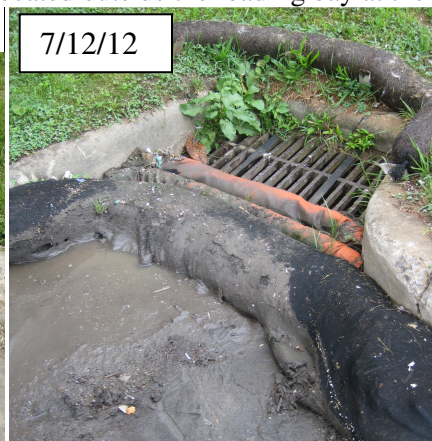
4. The facility had made efforts to protect the drain located outside the loading bay at the transfer station.

During previous inspections the screening “sleeves” were clogged and overflowing. It is recommended that these drains be placed on a regular inspection schedule. It has been stated previously that this drain is not a stormwater drain. **Please confirm this and submit a drawing (simple schematic) to the Section (A. Keller) indicating the location of all stormwater drains vs. sewer line drains within the vicinity of the transfer station.**
